Stress fracture of the femoral component in total knee replacement: a report of 3 cases

Summary. *We report 3 cases of stress fracture of the femoral component (small size Whiteside Ortholoc II) in total knee replacements which occurred at 32, 52, and 73 months after operation. The site was at the junction between the medial posterior bevelled surface and the posterior flange. The most likely cause of failure is due to the thinness of the metal at this point.*

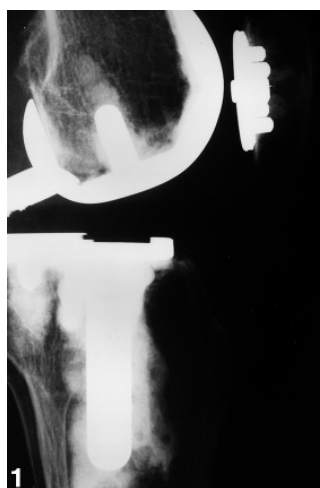
Thirty-two months after the first operation, her left knee suddenly became painful and radiographs showed a fracture of the femoral component (Fig. 1) between the posterior bevelled surface and the distal flange of the medial implant. The cement mantle was approximately 1 mm thick. Scanning electron microscopy showed signs of a fatigue fracture.

Fig. 1. Case 1. Lateral radiograph showing a fracture of the femoral component

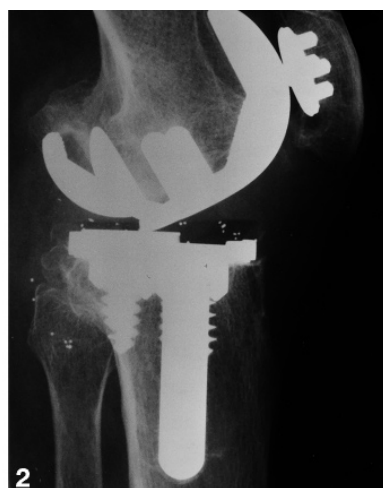
Fifty-two months after the first operation, she developed pain in her right knee. Radiographs showed a fracture of the femoral component (Fig. 2) at the same site as in case 1. There were loose beads from the porous layer around the implant. There was no bony ingrowth on the porous surface.

Fig. 2. Case 2. The component is broken and loose beads are present around the implant

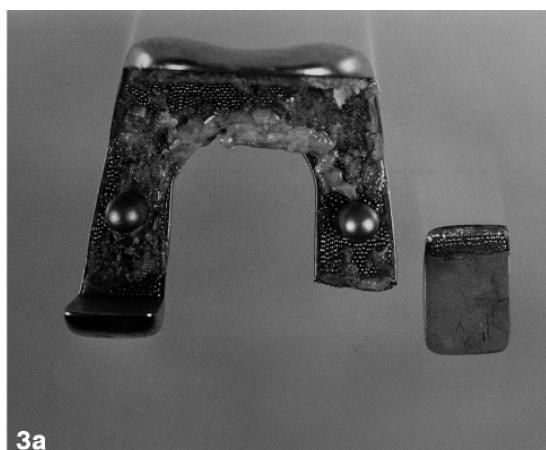
3a

Fig. 3. Case 3. **a** The femoral component is fractured at the junction of the bevelled area and the posterior flange. **b** Scanning electron microscopy showing a stress fracture

Seventy-three months after the second operation, she suddenly developed pain in her left knee. The femoral component had fractured (Fig. 3 a) at the same site as in cases 1 and 2. As in case 2, bony ingrowth had not occurred and loose beads were scattered around the implant. Scanning electron microscopy showed a typical stress fracture (Fig. 3 b).

The thickness of the small size femoral component of the Ortholoc II is only 3 mm which is significantly less than that of any other implant available. This is the critical factor responsible for these failures [5]. In addition, the sintering process of the double beads makes the implant weaker [2]. In our cases, the fixation of the porous layer to bone was not well achieved and may have led to
